**Flood Control Project Maintenance
Levee Inspections**
LMA District Cover Sheet
Spring 2017 Levee Inspection Results

Reclamation District No. 2060 Hastings

Spring 2017 Levee Inspection Results

Levee Inspection Report By Mile - Spring 2017

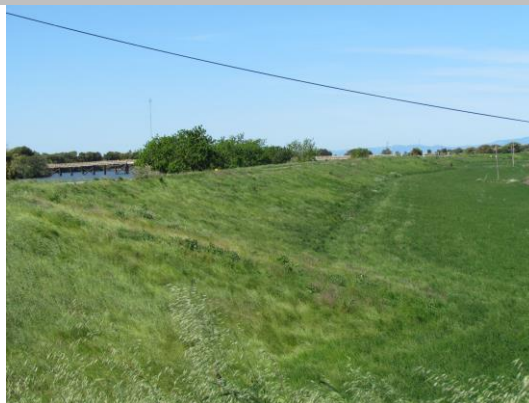
Photo 1 of 1 : SP_2017_RD2060_241_5_20170424_00008.jpg

RD 2060 Landside slope looking downstream from levee mile 0.00.

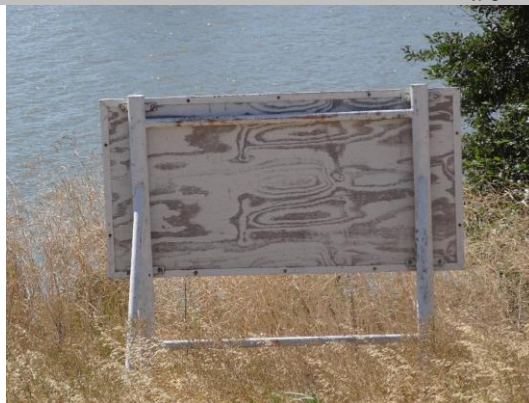
Photo 1 of 2 : UCIP_SP_2017_41908_30541.jpg

LM Start	3.65	Rating **	M	Issue No.	20
LM End	3.65	Issue Type +	En	Location *	WS
Category	Supplemental			GPS Latitude/Longitude	
				Start	End
Item	DWR UCIP Field Study			38.261314 °	38.261314 °
				-121.749191 °	-121.749191 °
DWR ID					
Comment Code					
Inspector Comment					
FS_ID:41908 DS_ID:22050 EP_NO: 10119 Repair Type: Non-Urgent Crossing Status: Indicator Found UCIP Comments: Need to contact owner and verify status of crossing. FIELD_STRUCT_DESC: 8-5/8-inch gas pipeline crosses Lindsey Slough to R.D. 536. Gasline marker on LS and sign board on WS. (Permit no. 10119) FS Date: 8/15/2013

WS view: gasoline sign board on levee slope.

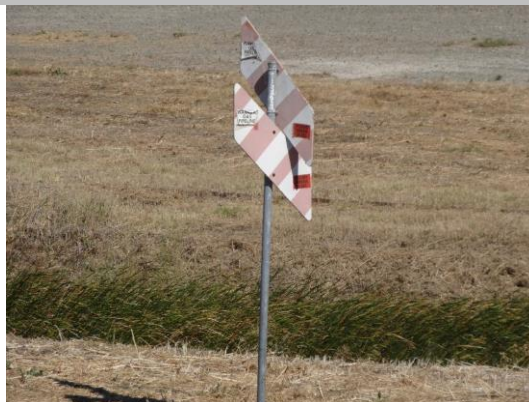
Photo 2 of 2 : UCIP_SP_2017_41908_30540.jpg

LS view: gasoline indicator across the road from levee toe.

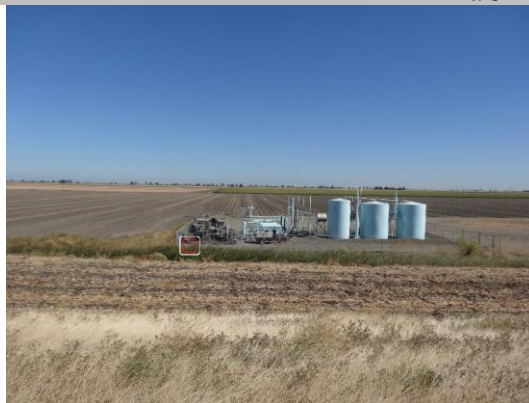
Photo 1 of 3 : UCIP_SP_2017_41878_30549.jpg

LM Start	3.76	Rating **	M	Issue No.	21
LM End	3.76	Issue Type +	En	Location *	WS
Category	Supplemental			GPS Latitude/Longitude	
				Start	End
Item	DWR UCIP Field Study			38.261211 °	38.261211 °
				-121.751117 °	-121.751117 °
DWR ID					
Comment Code					
Inspector Comment					
FS_ID:41878					
DS_ID:22045					
EP_NO: 12784					
Repair Type: Non-Urgent					
Crossing Status: Indicator Found					
UCIP Comments: Need to contact owner to determine status and install signs if appropriate.					
FIELD_STRUCT_DESC: 8.625-inch diameter natural gas pipeline across the channel and both levees of Lindsey Slough. 4 feet below the crown. Gasline marker found off LS (Permit No. 12784).					
FS Date: 8/15/2013

LS view: a gas plant and gasline indicator found on LS.

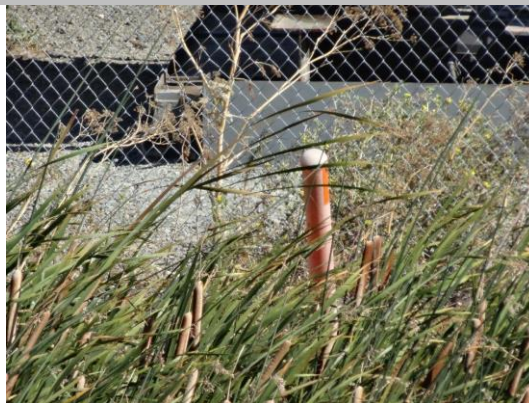
Photo 2 of 3 : UCIP_SP_2017_41878_30548.jpg

LS view: closer view of gasline indicator found on LS.

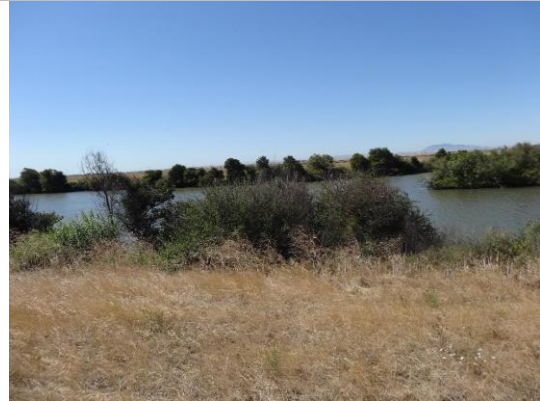
Photo 3 of 3 : UCIP_SP_2017_41878_30547.jpg

LM Start	3.76	Rating **	M	Issue No.	21 (cont)
LM End	3.76	Issue Type +	En	Location *	WS
Category	Supplemental			GPS Latitude/Longitude	
				Start	End
Item	DWR UCIP Field Study			38.261211 °	38.261211 °
				-121.751117 °	-121.751117 °
DWR ID					
Comment Code					
Inspector Comment					
FS_ID:41878 DS_ID:22045 EP_NO: 12784 Repair Type: Non-Urgent Crossing Status: Indicator Found UCIP Comments: Need to contact owner to determine status and install signs if appropriate. FIELD_STRUCT_DESC: 8.625-inch diameter natural gas pipeline across the channel and both levees of Lindsey Slough. 4 feet below the crown. Gasline marker found off LS (Permit No. 12784). FS Date: 8/15/2013

WS view: no indicators found on WS.

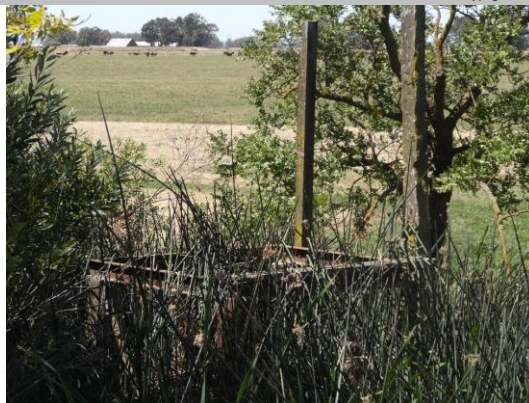
Photo 1 of 2 : UCIP_SP_2017_46769_31088.jpg

FS_ID:46769
DS_ID:22059
EP_NO: N/A
Repair Type: Non-Urgent
Crossing Status: Indicator Found
UCIP Comments: - Abandoned pump structure in stream needs proper abandonment- Not accessible due to wired fence
FIELD_STRUCT_DESC: *ABANDONED* pump structure in stream and a concrete distribution on landside. Not accessible due to wired fence.
FS Date: 8/15/2013

WS view: abandoned pump support in stream/channel. Not accessible due to vegetation.

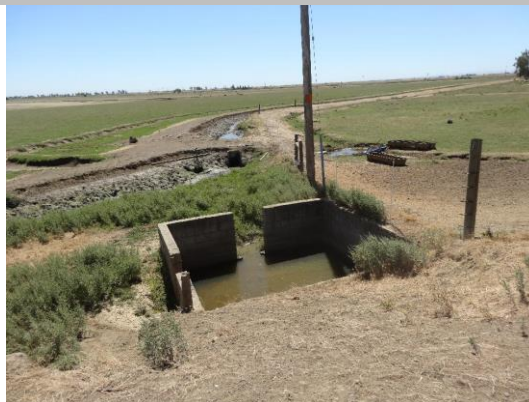
Photo 2 of 2 : UCIP_SP_2017_46769_31087.jpg

LS view: abandoned concrete distribution box. Not accessible due to wire fence.

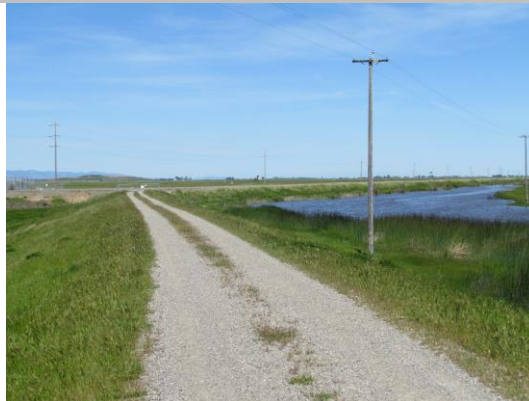
Photo 1 of 1 : SP_2017_RD2060_242_8_20170424_00010.jpg

Looking downstream from levee mile 0.01.

LM Start	0.01	Rating **	A	Issue No.	7
LM End	0.39	Issue Type +	Ma	Location *	LS
Category	Earthen Levee			GPS Latitude/Longitude	
				Start	End
Item	Vegetation			38.275085 °	38.280287 °
				-121.794940 °	-121.795935 °
DWR ID	DWR_RD2060_02_s_2017_7				
Comment Code					
V1 : Control annual grass and weeds on the levee slopes and easements.					
Inspector Comment					
The vegetation is acceptable.

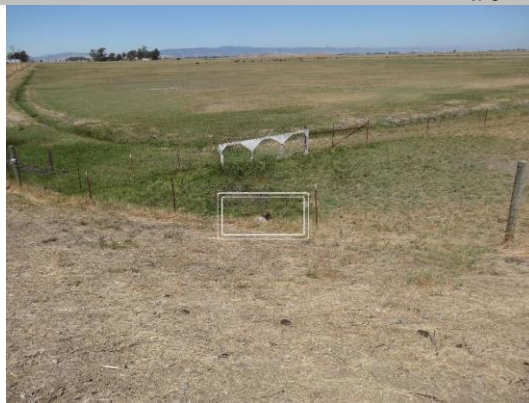
Photo 1 of 3 : UCIP_SP_2017_18386_30873.jpg

LM Start	1.74	Rating **	M	Issue No.	13
LM End	1.74	Issue Type +	En	Location *	WS
Category	Supplemental			GPS Latitude/Longitude	
				Start	End
Item	DWR UCIP Field Study			38.285219 °	38.285219 °
				-121.777085 °	-121.777085 °
DWR ID					
Comment Code					
Inspector Comment					
FS_ID:18386					
DS_ID:22056					
EP_NO: 10148					
Repair Type: Non-Urgent					
Crossing Status: Found					
UCIP Comments: U-type concrete headwall on LS. Not accessible due to fence.Vegetation is partially blocking inlet & outlet pipe.					
FIELD_STRUCT_DESC: 24-inch CM drainpipe through levee, 16.0 feet below crown, flap gate on waterward end. U-type concrete headwall on LS. Not accessible due to fence. Vegetation is partially blocking inlet & outlet pipe.					
FS Date: 8/15/2013

WS view: overview of CMP from levee.

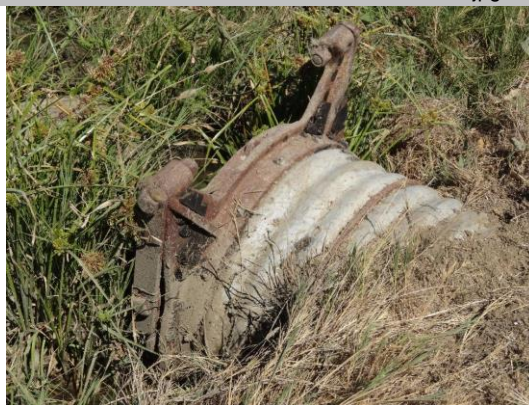
Photo 2 of 3 : UCIP_SP_2017_18386_30872.jpg

WS view: CM pipe with flap gate. Not accessible. Vegetation is partially blocking outlet pipe.

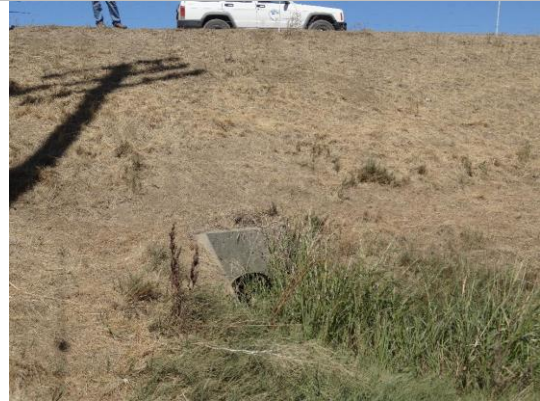
Photo 3 of 3 : UCIP_SP_2017_18386_30874.jpg

LM Start	1.74	Rating **	M	Issue No.	13 (cont)
LM End	1.74	Issue Type +	En	Location *	WS
Category	Supplemental			GPS Latitude/Longitude	
				Start	End
Item	DWR UCIP Field Study			38.285219 °	38.285219 °
				-121.777085 °	-121.777085 °
DWR ID					
Comment Code					
Inspector Comment					
FS_ID:18386					
DS_ID:22056					
EP_NO: 10148					
Repair Type: Non-Urgent					
Crossing Status: Found					
UCIP Comments: U-type concrete headwall on LS. Not accessible due to fence.Vegetation is partially blocking inlet & outlet pipe.					
FIELD_STRUCT_DESC: 24-inch CM drainpipe through levee, 16.0 feet below crown, flap gate on waterward end. U-type concrete headwall on LS. Not accessible due to fence. Vegetation is partially blocking inlet & outlet pipe.					
FS Date: 8/15/2013

LS view: CM pipe with U shaped concrete headwall. Not accessible. Vegetation is partially blocking inlet pipe.

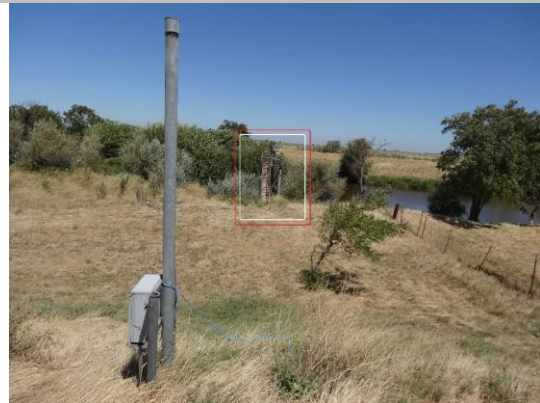
Photo 1 of 3 : UCIP_SP_2017_41668_31161.jpg

LM Start	2.15	Rating **	M	Issue No.	14
LM End	2.15	Issue Type +	En	Location *	WS
Category	Supplemental			GPS Latitude/Longitude	
				Start	End
Item	DWR UCIP Field Study			38.290440 °	38.290440 °
				-121.774808 °	-121.774808 °
DWR ID					
Comment Code					
Inspector Comment					
FS_ID:41668					
DS_ID:22060					
EP_NO: 5927					
Repair Type: Non-Urgent					
Crossing Status: Found					
UCIP Comments: verify pipe has been abandoned properly. -					
abandoned pump and pipe.- electrical box on WS shoulder.					
FIELD_STRUCT_DESC: *Abandoned* 18-inch steel pipe through levee					
4.0 feet below crown, siphon breaker on landward slope. Pump on piling					
on bank, distribution box at landward toe. (Permit No. 5927 - Cache					
Slough Pheasant Club).					
FS Date: 8/15/2013

WS view: electrical box on pole and pump structure in background.

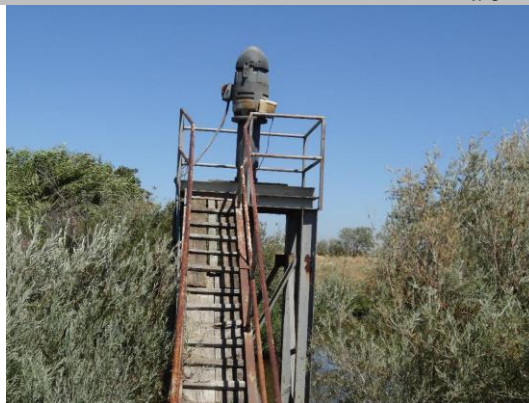
Photo 2 of 3 : UCIP_SP_2017_41668_31160.jpg

WS view: pump on pile structure with stairs on bank.

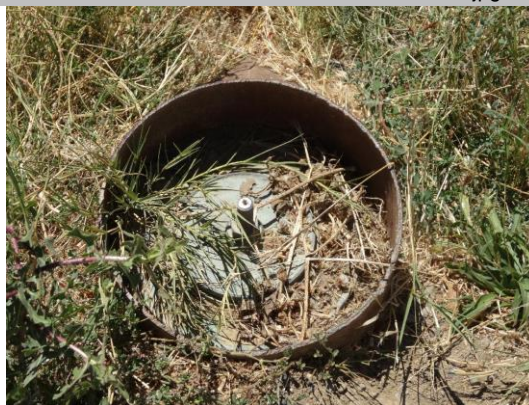
Photo 3 of 3 : UCIP_SP_2017_41668_31163.jpg

LS view: obstructed siphon breaker in steel riser on levee slope.

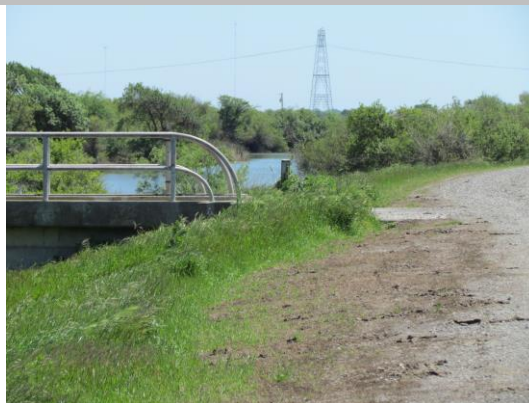
Photo 1 of 1 : SP_2017_RD2060_243_14_20170424_00022.jpg

Looking downstream from levee mile 0.01 at the waterside slope and shoulder.

LM Start	0.01	Rating **	M	Issue No.	13
LM End	5.01	Issue Type +	Ma	Location *	LS
Category	Earthen Levee			GPS Latitude/Longitude	
				Start	End
Item	Vegetation			38.296617 °	38.247650 °
				-121.748565 °	-121.696217 °
DWR ID	DWR_RD2060_03_s_2017_13				
Comment Code					
V1 : Control annual grass and weeds on the levee slopes and easements.					
Inspector Comment					
Spray to control the annual grass and weeds from the landside slope.

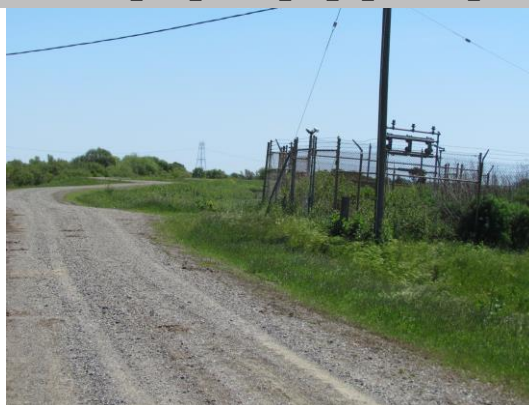
Photo 1 of 1 : SP_2017_RD2060_243_13_20170424_00016.jpg

Looking downstream from levee mile 0.01.

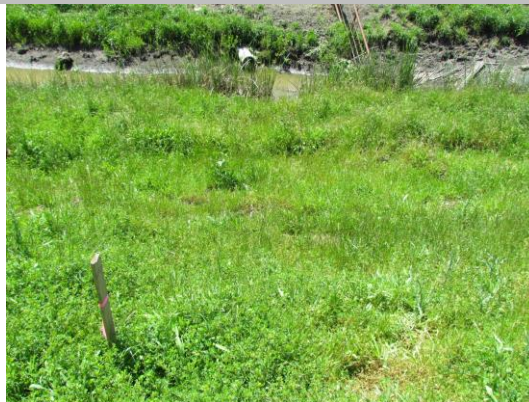
Photo 1 of 2 : SP_2017_RD2060_243_16_20170424_00023.jpg

LM Start	0.07	Rating **	U	Issue No.	16
LM End	0.07	Issue Type +	Ma	Location *	LS
Category	Earthen Levee			GPS Latitude/Longitude	
				Start	End
Item	Erosion / Bank Caving			38.296350 °	38.296302 °
				-121.747642 °	-121.747565 °
DWR ID	DWR_RD2060_03_s_2017_16				
Comment Code					
E1 : Note and monitor erosion site.					
Inspector Comment

Looking down from the shoulder at the sloughing in the slope towards the irrigation ditch at toe.

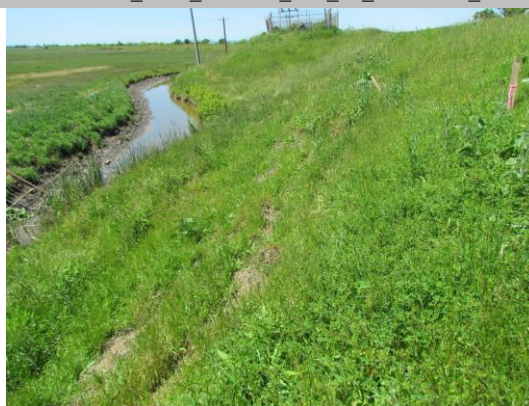
Photo 2 of 2 : SP_2017_RD2060_243_16_20170424_00025.jpg

Standing on the slope looking upstream at the slough.

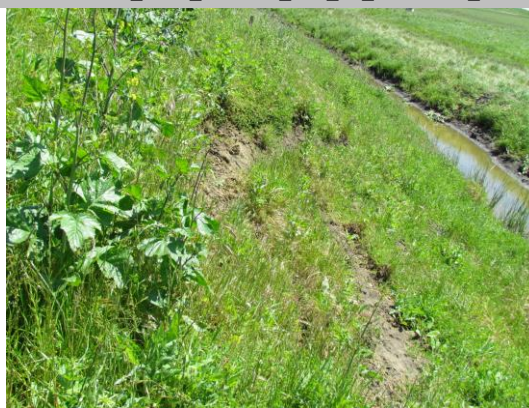
Photo 1 of 2 : SP_2017_RD2060_243_19_20170424_00017.jpg

LM Start	0.15	Rating **	M	Issue No.	19
LM End	0.19	Issue Type +	Ma	Location *	LS
Category	Earthen Levee			GPS Latitude/Longitude	
				Start	End
Item	Slope Stability			38.295738 °	38.295559 °
				-121.746293 °	-121.745583 °
DWR ID	DWR_RD2060_03_s_2017_19				
Comment Code					
S1 : Repair slope instability.					
Inspector Comment					
There are several signs of sloughing occuring on the slope notices after the flood event Feb. 2017 storm.

Stand at levee mile 0.15 looking downstream from the landside slope.

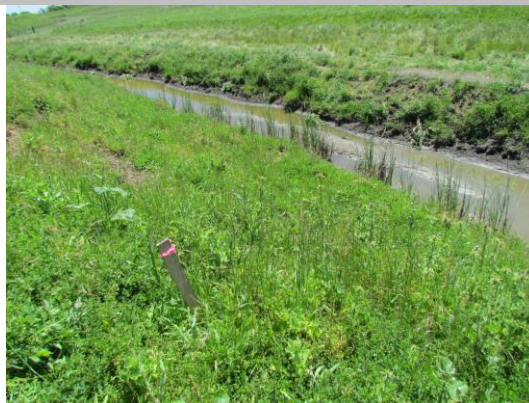
Photo 2 of 2 : SP_2017_RD2060_243_19_20170424_00018.jpg

Just upstream of the erosion site looking downstream from the landside slope.

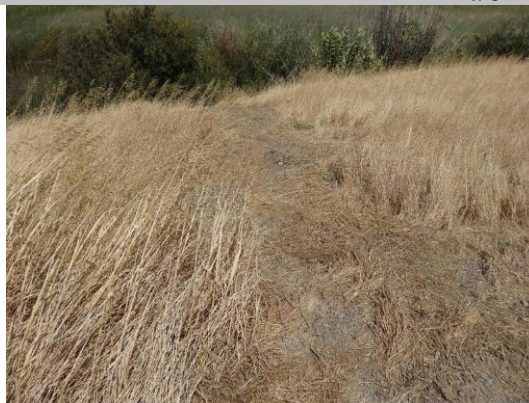
Photo 1 of 2 : UCIP_SP_2017_18727_31317.jpg

FS_ID:18727
DS_ID:22067
EP_NO: N/A
Repair Type: Non-Urgent
Crossing Status: Found
UCIP Comments: Seem abandoned. Not found- pump on LS. Needs more exploration.
FIELD_STRUCT_DESC: 6-inch steel pipe through the levee, 2.8 feet below the crown. O&M Manual SAC 107, April 1959.
FS Date: 8/15/2013

Waterside view: levee slope.

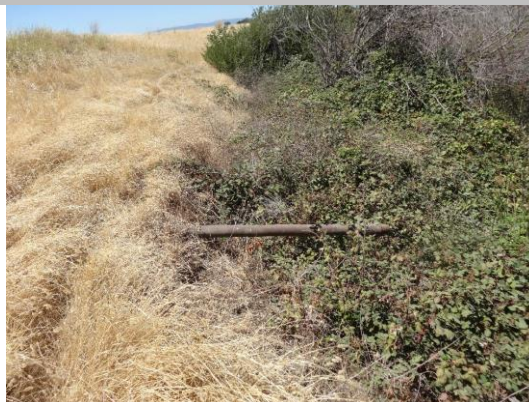
Photo 2 of 2 : UCIP_SP_2017_18727_31316.jpg

Waterside view: levee slope and a steel pipe.

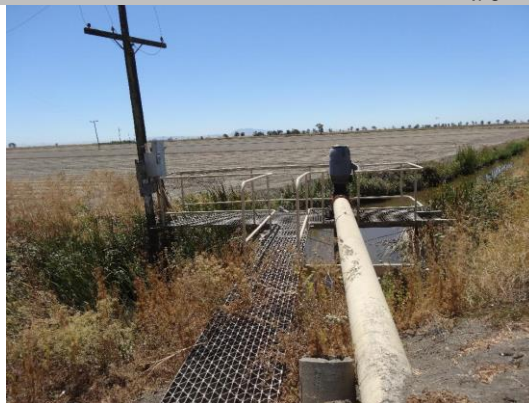
Photo 1 of 3 : UCIP_SP_2017_18726_31314.jpg

LM Start	0.90	Rating **	M	Issue No.	21
LM End	0.90	Issue Type +	En	Location *	LS
Category	Supplemental			GPS Latitude/Longitude	
				Start	End
Item	DWR UCIP Field Study			38.290684 °	38.290684 °
				-121.735639 °	-121.735639 °
DWR ID					
Comment Code					
Inspector Comment					
FS_ID:18726 DS_ID:22063 EP_NO: 6342 Repair Type: Non-Urgent Crossing Status: Found UCIP Comments: Leaky siphon breaker may need to be repaired. Dense vegetation on WS.Not found- gate valve on LS. FIELD_STRUCT_DESC: 16-inch steel pipe through levee 8.0 feet below crown, vertical pump in drain ditch on land-side. Siphon breaker on waterside. (App. No. 6342-A - Hastings Farms) FS Date: 8/15/2013

Landside view: pump, service pole, steel support structure, walkway, and pipe.

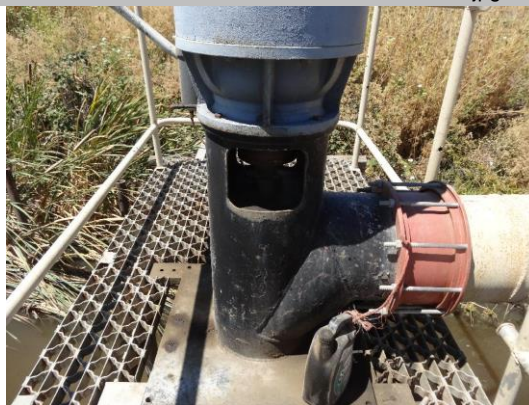
Photo 2 of 3 : UCIP_SP_2017_18726_31313.jpg

Landside view: pipe and pump on steel structure in drain ditch.

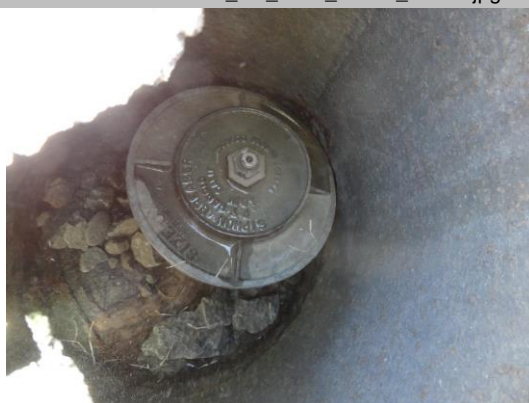
Photo 3 of 3 : UCIP_SP_2017_18726_31315.jpg

LM Start	0.90	Rating **	M	Issue No.	21 (cont)	
LM End	0.90	Issue Type +	En	Location *	LS	
Category	Supplemental			GPS Latitude/Longitude		
				Start	End	
Item	DWR UCIP Field Study			38.290684 °	38.290684 °	
				-121.735639 °	-121.735639 °	
DWR ID						
Comment Code						
Inspector Comment						
FS_ID:18726 DS_ID:22063 EP_NO: 6342 Repair Type: Non-Urgent Crossing Status: Found UCIP Comments: Leaky siphon breaker may need to be repaired. Dense vegetation on WS.Not found- gate valve on LS. FIELD_STRUCT_DESC: 16-inch steel pipe through levee 8.0 feet below crown, vertical pump in drain ditch on land-side. Siphon breaker on waterside. (App. No. 6342-A - Hastings Farms) FS Date: 8/15/2013

Waterside view: only leaky siphon breaker found.

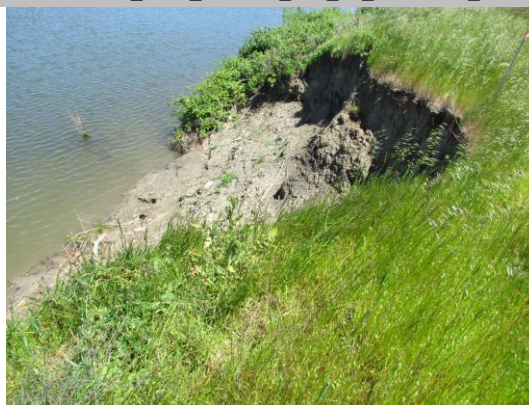
Photo 1 of 2 : SP_2017_RD2060_243_18_20170424_00019.jpg

LM Start	1.12	Rating **	U	Issue No.	18
LM End	1.12	Issue Type +	Ma	Location *	WS
Category	Earthen Levee			GPS Latitude/Longitude	
				Start	End
Item	Slope Stability			38.290558 °	38.290558 °
				-121.731580 °	-121.731580 °
DWR ID	DWR_RD2060_03_s_2017_18				
Comment Code					
S1 : Repair slope instability.					
Inspector Comment					
The District has scheduled repairs of this site.

Looking downstream at the erosion in the waterside slope and toe.

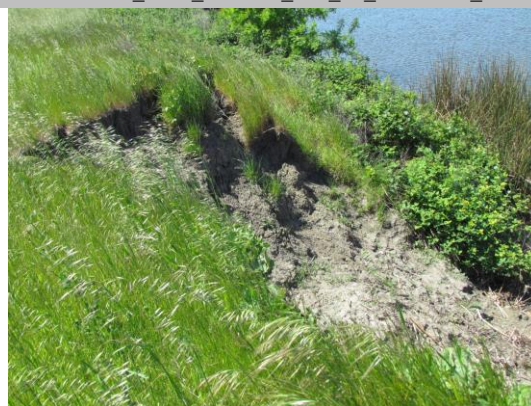
Photo 2 of 2 : SP_2017_RD2060_243_18_20170424_00021.jpg

LM Start	1.12	Rating **	U	Issue No.	18 (cont)	
LM End	1.12	Issue Type +	Ma	Location *	WS	
Category	Earthen Levee			GPS Latitude/Longitude		
				Start		End
Item	Slope Stability			38.290558 °		38.290558 °
				-121.731580 °		-121.731580 °
DWR ID	DWR_RD2060_03_s_2017_18					
Comment Code						
S1 : Repair slope instability.						
Inspector Comment						
The District has scheduled repairs of this site.

Looking upstream at the erosion on the waterside slope.

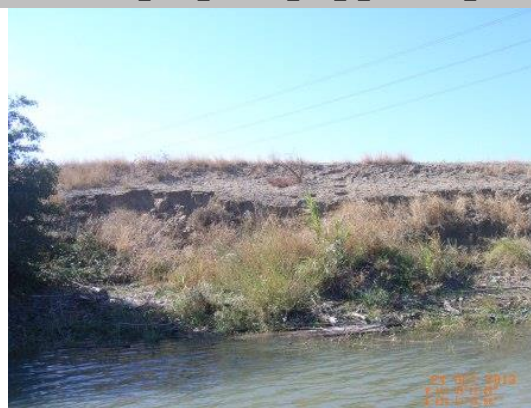
Photo 1 of 1 : SP_2017_RD2060_243_8_20170404_00007.jpg

LM Start	1.52	Rating **	M	Issue No.	8
LM End	1.74	Issue Type +	Ma	Location *	WS
Category	Supplemental			GPS Latitude/Longitude	
				Start	End
Item	2015 USACE Erosion Survey, DRAFT			38.288598 °	38.286051 °
				-121.725184 °	-121.722818 °
DWR ID	DWR_RD2060_03_s_2016_8				
Comment Code					
Inspector Comment					
Site added in 1997 and removed in 2003. 2005 - Put back in the inventory. 2006 - Stone repair at the middle of the site. 2011 - Some rock place at toe in the past year. 2013 - Site extended both upstream and downstream to include new erosion pockets. 2015: No observed changes. [2015 Site ID: CHS_23-6_R]

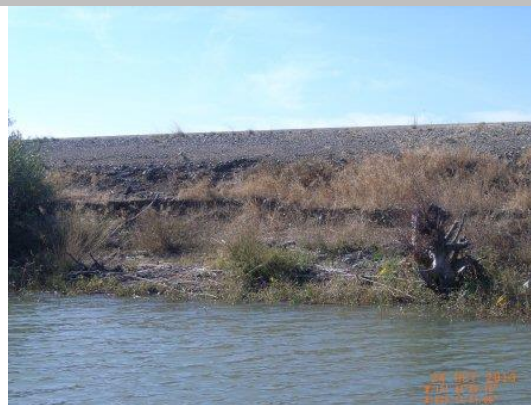
Photo 1 of 1 : SP_2017_RD2060_243_1_20170404_00001.jpg

LM Start	2.02	Rating **	M	Issue No.	1
LM End	2.08	Issue Type +	Ma	Location *	WS
Category	Supplemental			GPS Latitude/Longitude	
				Start	End
Item	2015 USACE Erosion Survey, DRAFT			38.284105 °	38.283302 °
				-121.718471 °	-121.717814 °
DWR ID	DWR_RD2060_03_s_2016_1				
Comment Code					
Inspector Comment					
2010 - Small maintenance site. 2015: No observed changes. [2015 Site ID: CHS_23-0_R]

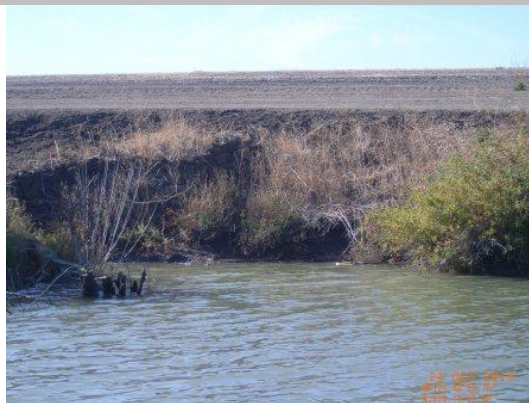
Photo 1 of 1 : SP_2017_RD2060_243_7_20170404_00006.jpg

LM Start	2.18	Rating **	M	Issue No.	7
LM End	2.23	Issue Type +	Ma	Location *	WS
Category	Supplemental			GPS Latitude/Longitude	
				Start	End
Item	2015 USACE Erosion Survey, DRAFT			38.282100 °	38.281510 °
				-121.716817 °	-121.716319 °
DWR ID	DWR_RD2060_03_s_2016_7				
Comment Code					
Inspector Comment					
2007 - Geotechnical failure of midside slope and wave wash/scalloping in toe area. Stone revetment upstream and downstream of site. Similar sites are present all along the right bank downstream of this site, most could be repaired with some maintenance. 2010 - Minor new erosion. 2015: No observed changes. [2015 Site ID: CHS 22-8 R]

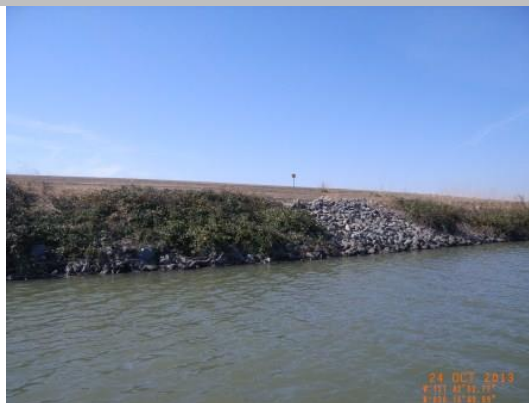
Photo 1 of 1 : SP_2017_RD2060_243_4_20170404_00003.jpg

LM Start	2.35	Rating **	M	Issue No.	4
LM End	2.53	Issue Type +	Ma	Location *	WS
Category	Supplemental			GPS Latitude/Longitude	
				Start	End
Item	2015 USACE Erosion Survey, DRAFT			38.280377 °	38.278306 °
				-121.714633 °	-121.712722 °
DWR ID	DWR_RD2060_03_s_2016_4				
Comment Code					
Inspector Comment					
2008 - Small scour pockets and mid-slope wave wash. 2010 - More vegetation growth, could be fixed through maintenance. 2011 - Site extended downstream and new erosion. 2015: No observed changes. [2015 Site ID: CHS_22-6_R]

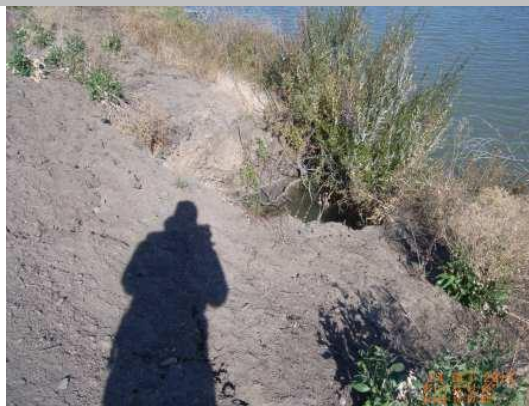
Photo 1 of 1 : SP_2017_RD2060_243_6_20170404_00005.jpg

LM Start	2.79	Rating **	M	Issue No.	6
LM End	2.79	Issue Type +	Ma	Location *	LS
Category	Earthen Levee			GPS Latitude/Longitude	
				Start	End
Item	Slope Stability			38.275302 °	38.275302 °
				-121.710130 °	-121.710127 °
DWR ID	DWR_RD2060_03_s_2016_6				
Comment Code					
S1 : Repair slope instability.					
Inspector Comment

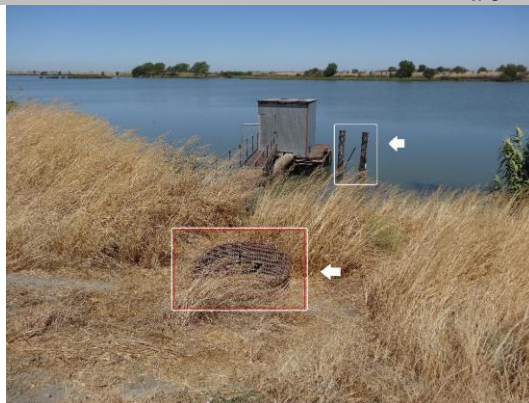
Photo 1 of 3 : UCIP_SP_2017_18723_31303.jpg

LM Start	3.24	Rating **	M	Issue No.	22
LM End	3.24	Issue Type +	En	Location *	WS
Category	Supplemental			GPS Latitude/Longitude	
				Start	End
Item	DWR UCIP Field Study			38.270151 °	38.270151 °
				-121.705782 °	-121.705782 °
DWR ID					
Comment Code					
Inspector Comment					
FS_ID:18723					
DS_ID:22064					
EP_NO: N/A					
Repair Type: Non-Urgent					
Crossing Status: Indicator Found					
UCIP Comments: Only a CMP riser was found on WS.					
FIELD_STRUCT_DESC: Only a CMP riser was found WS. All other features not found as described: 36-inch steel pipe through levee 15.0 feet below crown, slide gate in CM riser on waterward slope. (Asbestos bonded pipe.) Pump in pump house on pile structure in stream. Service pole and anchor on landward slope. Only a CMP riser was found WS.					
FS Date: 8/15/2013

WS view: slide gate in CMP riser (bottom- marked) and may be abandoned pile for pump support (marked- right).

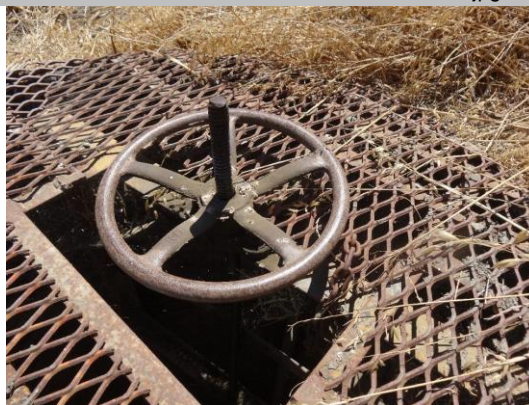
Photo 2 of 3 : UCIP_SP_2017_18723_31302.jpg

WS view: closer view of slide gate in CMP riser.

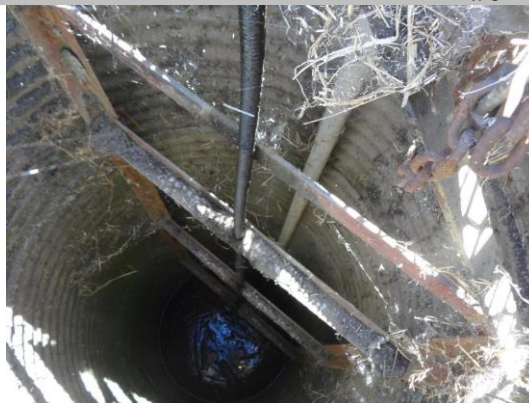
Photo 3 of 3 : UCIP_SP_2017_18723_31301.jpg

WS view: slide gate and air vent inside CMP riser.

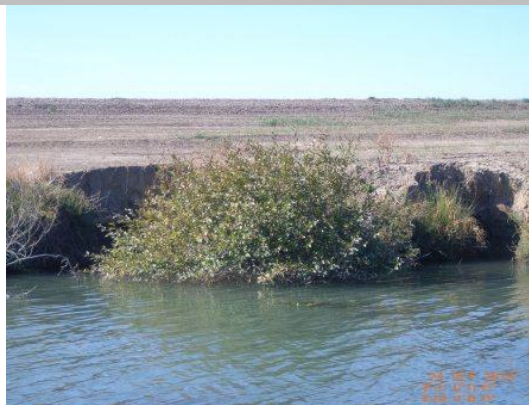
Photo 1 of 1 : SP_2017_RD2060_243_2_20170404_00002.jpg

LM Start	3.78	Rating **	M	Issue No.	2
LM End	4.09	Issue Type +	Ma	Location *	WS
Category	Supplemental			GPS Latitude/Longitude	
				Start	End
Item	2015 USACE Erosion Survey, DRAFT			38.264585 °	38.260593 °
				-121.698868 °	-121.696403 °
DWR ID	DWR_RD2060_03_s_2016_2				
Comment Code					
Inspector Comment					
2011 - Several pockets of erosion from rotational failure and slumping toe. 2013 - Site extended downstream to include new erosion pockets. 2015: No observed changes. [2015 Site ID: CHS_21-1_R]
